SITE ASSESSMENT REPORT
FOR
SUPERIOR TOY SITE
U.S. EPA ID: N/A
SSID#: N/A
TDD: T05-9304-005
PAN: EIL0792SAA

June 28, 1993

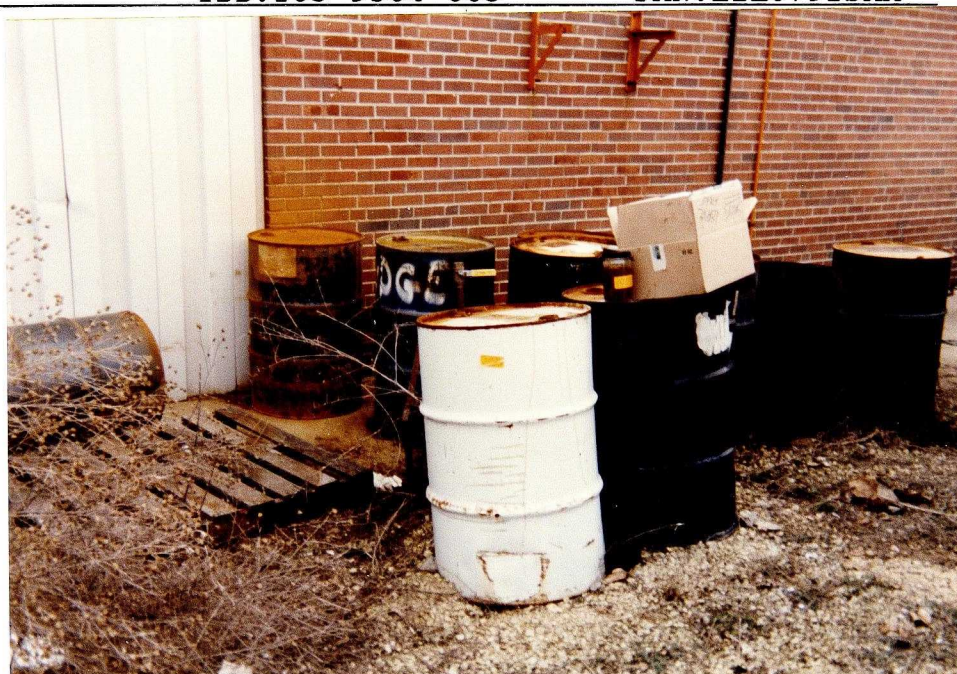
SAMPLE ID
(if applicable):
DS03

At 1130 hours, the reconnaissance was performed on the drums outside the facility near the loading dock. Two drums with no bung, had Hnu readings of 2000 ppm inside the drums but were empty. A drum sample (DS03) was collected from a black drum that was 2/3 full of a brown viscous material and had an Hnu reading of 250 ppm.

DESCRIPTION: DS03 was collected from the white drum with the orange tag. The drum was 2/3 full with a Hnu of 250 ppm.

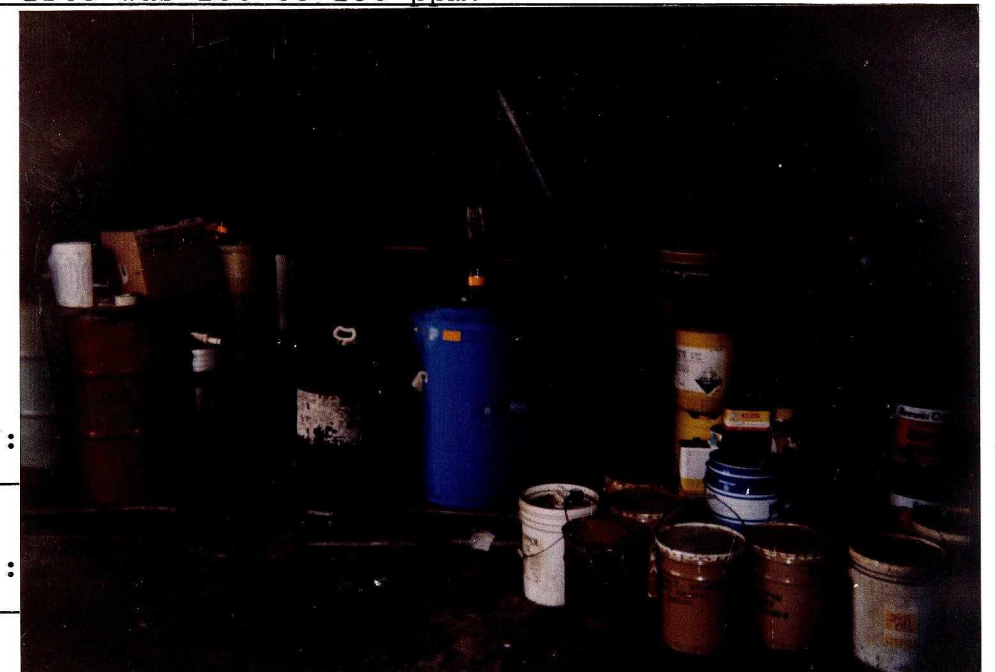
SAMPLE ID
(if applicable):
DS02

DESCRIPTION: DS02 was collected inside the storage building and had a corrosive label on the poly drum.

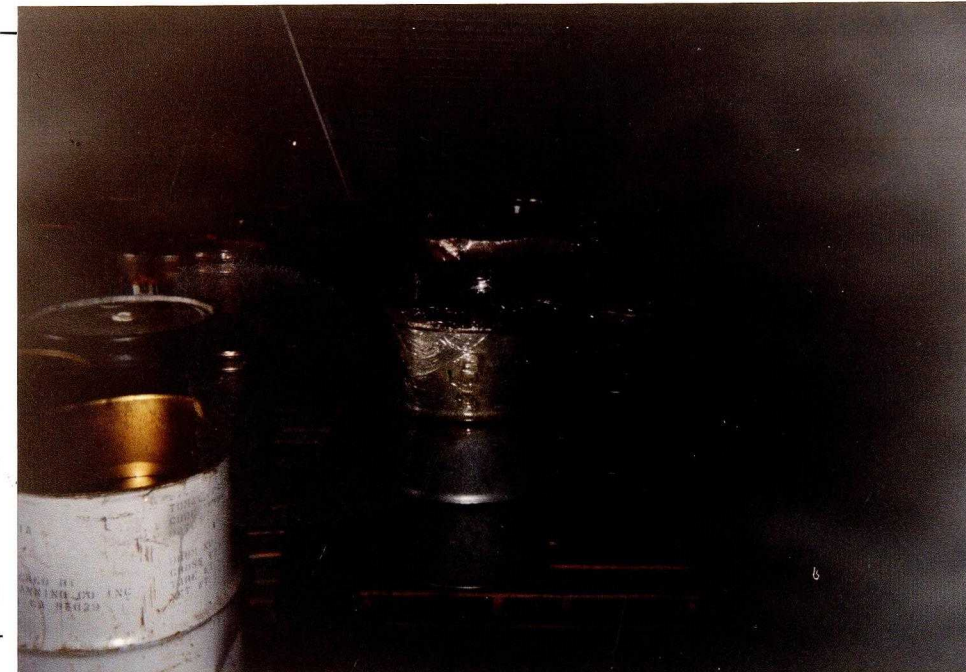
DESCRIPTION: Several rows of drums located in the storage building. Several oily drums were wrap in plastic (drums in the far right corner).

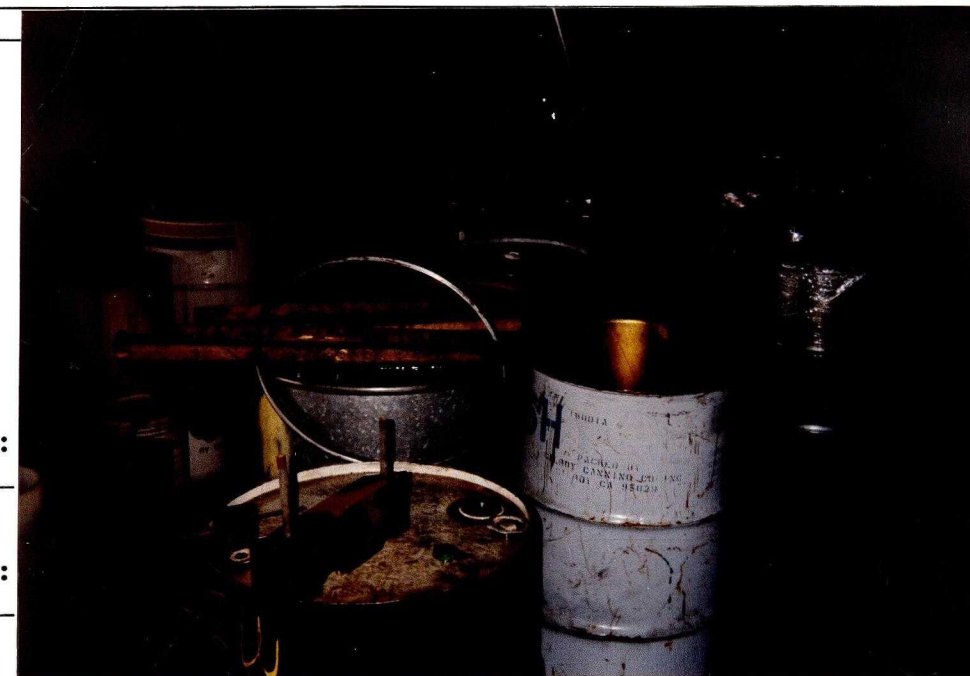
DESCRIPTION: Drum storage area, located at the northeast section of the storage building. The drums contained oily material and several drums did not have lids.
